CUMMINGS PARK & WEST BEACH WATERFRONT PLANNING STUDY

Prepared for:

STANTEC

May 2015

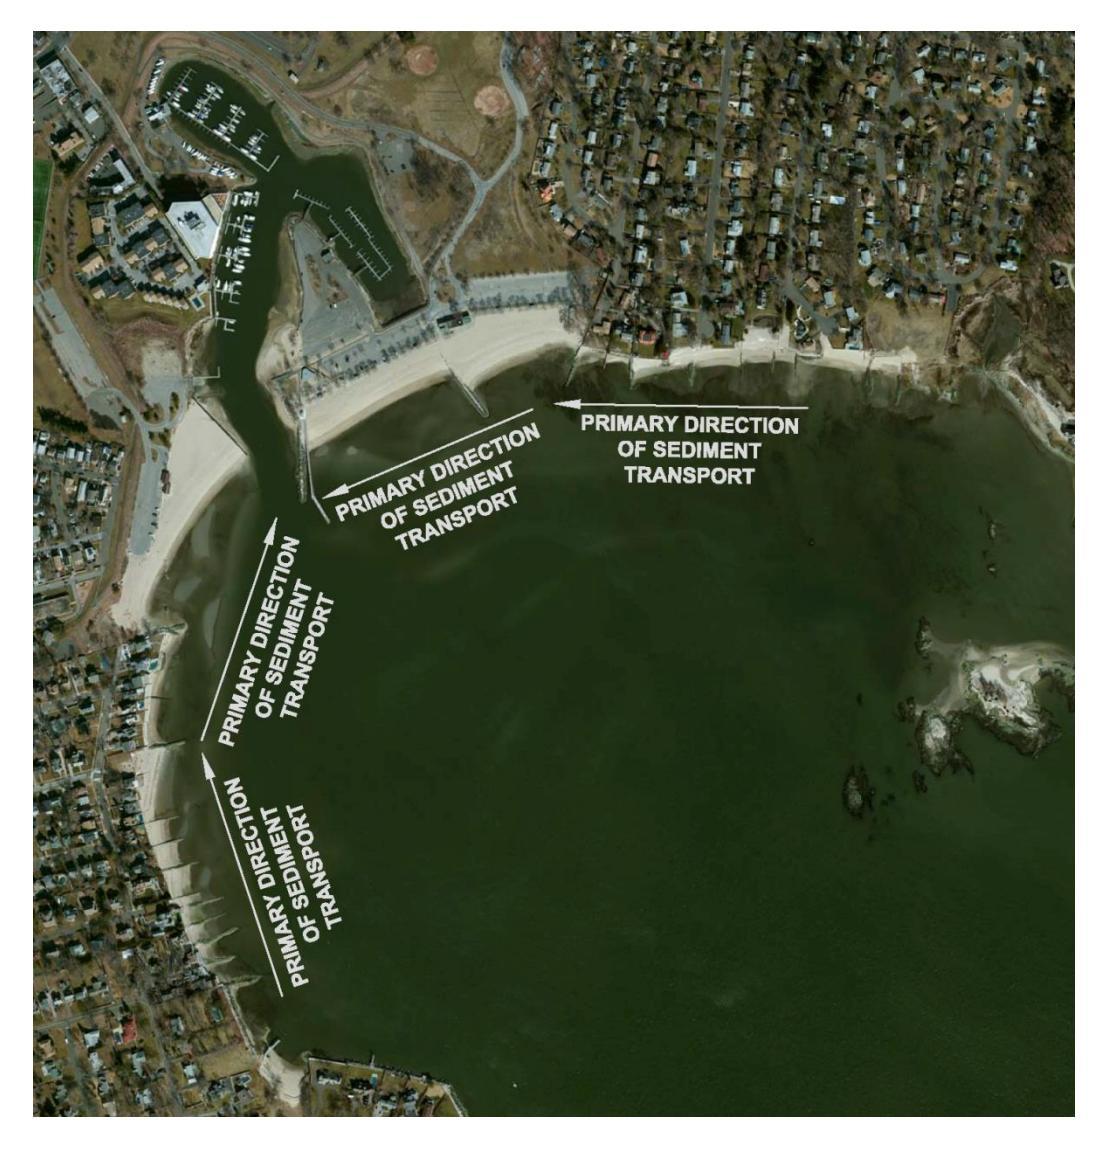
Figure 2: Predominant Sediment Transport Regime of Westcott Cove

Sediment transport within the littoral zones at the parks was also investigated. The direction of sediment transport along Cummings Beach is predominantly to the northwest, while the sediment transport on West Beach is to the northeast based upon qualitative analysis of beach forms as shown

on the historic aerial photographs. It is the opinion of **RACE** that this sediment transport is due to the effect of local topography on wave refraction. Refraction of waves in the nearshore region results in a predominant transport of beach materials towards the channel. This opinion, as noted, is illustrated by the annotated aerial photograph below which indicates sediment transport to the northeast on the west side of the cove and to the northwest on the east side of the cove. The indication of transport direction is demonstrated by the location of the sand depletion on the downdrift side of the visible groins.

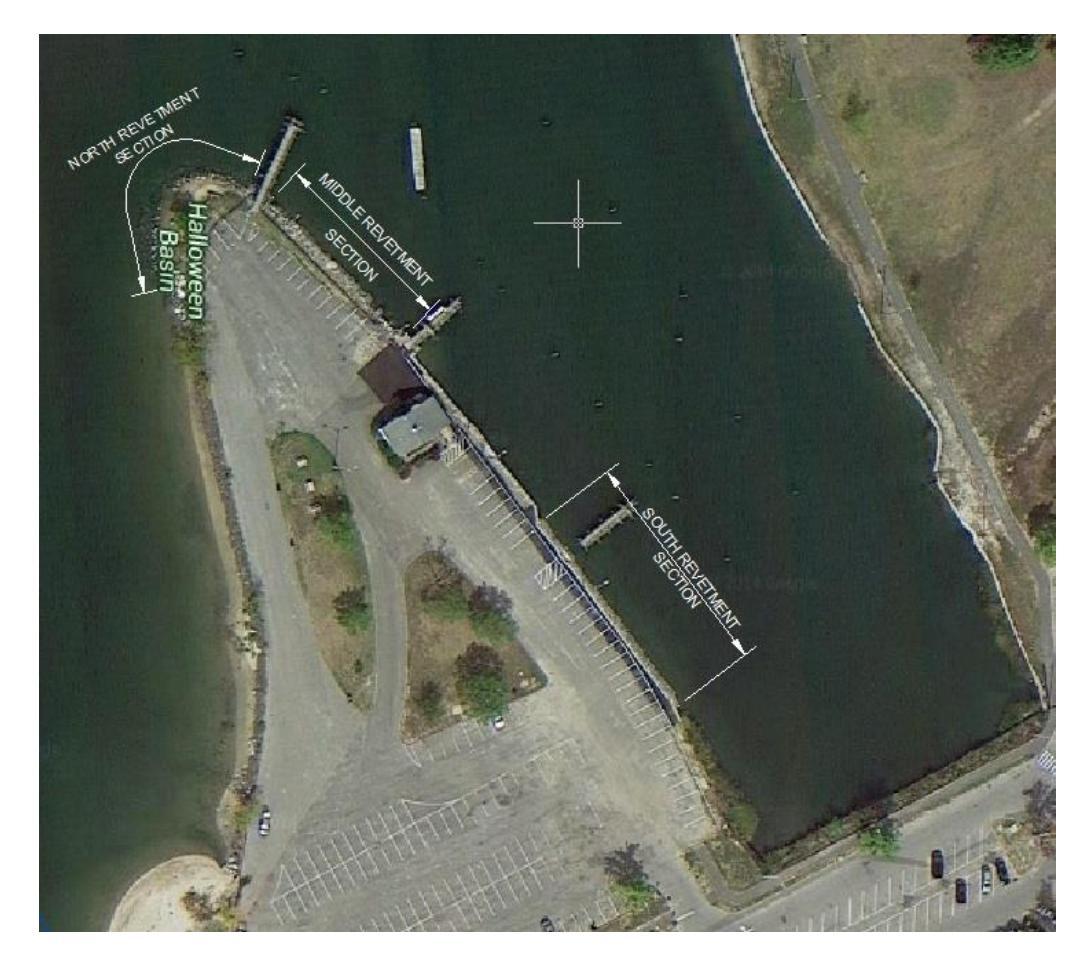
Figure 3: Revetment Locations

Stone revetments as well as stone walls provide protection to the earth embankment around Cummings Marina. A majority of the Cummings Marina eastern shoreline is stone revetment. There are two section within the eastern shoreline that are not revetments. One section is a grouted stone wall and the other is a dry-stacked stone wall. These two section are explained in section 5.1.g. The revetment section have been separated into northern, middle and southern sections as depicted in Figure 3.

The northern section of revetment, which is located north of Pier A, extends around the point and is approximately 160 linear feet. The stones vary in size with an average stone approximately 2'-6" in diameter. The riprap does not appear to extend to the top of the slope and sections of the embankment appear to have eroded throughout the years. The riprap appears to have been placed on the embankment without any filter layer or foundation layer. It was also noted that there are numerous voids throughout the revetment. Overall this section appears to be in poor condition and too low to provide protection for the embankment. It is recommended that this section of revetment be repaired.

The southern revetment which is in the vicinity of Pier C, is approximately 150-ft in length and appears to have been installed recently. It was noted that a timber bulkhead was installed in this location but has since been replaced. The stone revetment is sloped at approximately 1 vertical to 1.8 horizontal and has an average stone size of approximately 18". Overall the revetment appears to be in good condition.

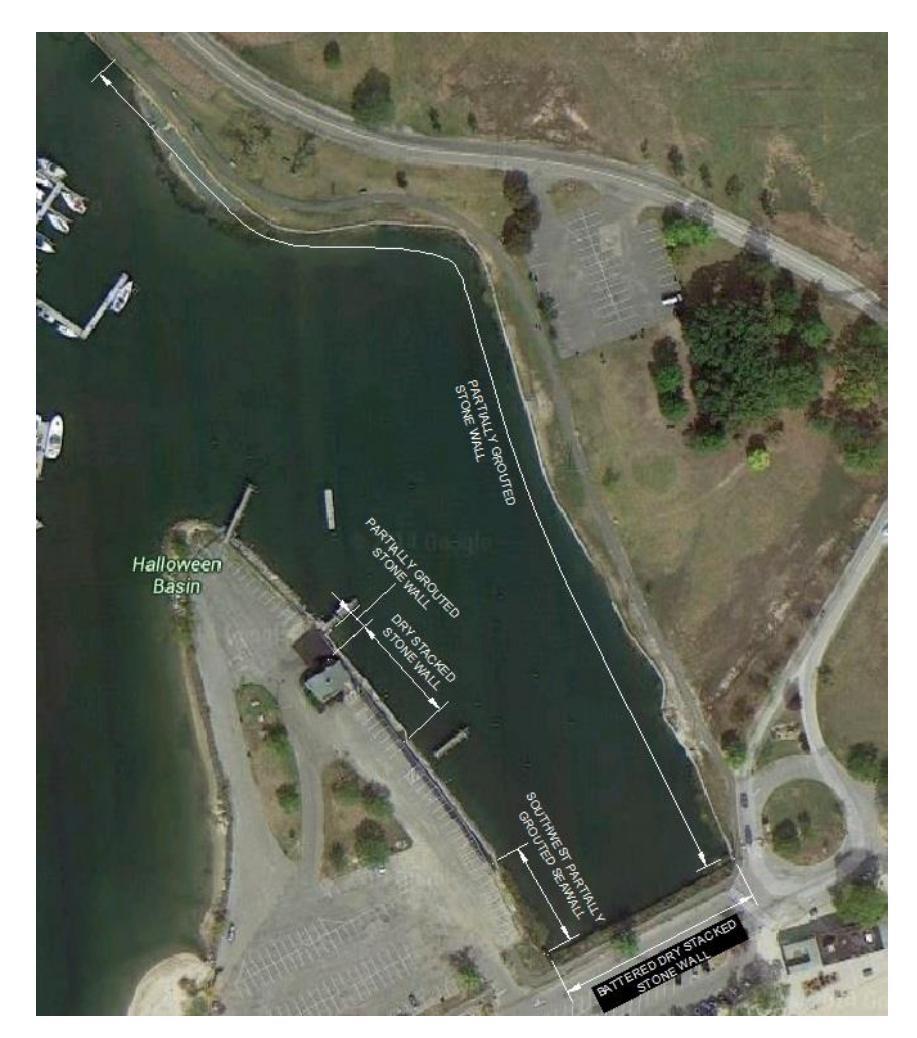
Figure 4: Stone Wall Locations

Stone seawalls are the dominate structure protecting the marinas shoreline. There are a variety of construction types seen throughout this site from vertical dry-stacked stone walls, to battered dry-stacked stone walls, to partially grouted stone walls all with the varying average stone sizes. Figure 4 below depicts the stone wall location as well as the construction type.

As depicted in Figure 4, south of Pier B is a 2-ft wide partially grouted stone wall which extends approximately 15-ft and ties into a dry-stacked stone wall. The partially grouted stone wall is installed were the old boat ramp once resided. It was noted at the north end of the wall, at the intersection between the partially grouted stone wall and
